USEPA/ARCS V BVSPC Weekly Field Oversight Summary

Reporting Period: November 18 - November 21, 1996

BVSPC Project No. 71670

Site Name/Location: ACS, Griffith, IN

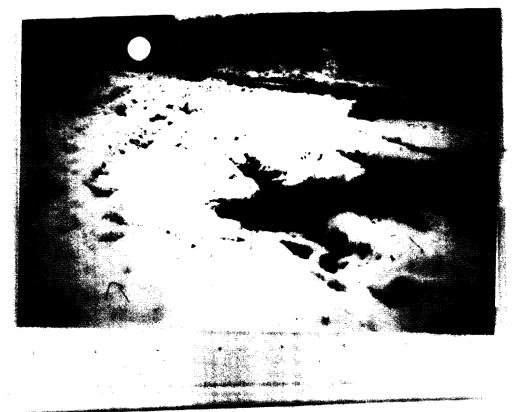
Photo #: 22 Roll: 1 Time: 0830 Date: 11-21-96

Facing southwest. North end of the PCB-containing soils Description:

excavation along the PGCS extraction trench alignment.

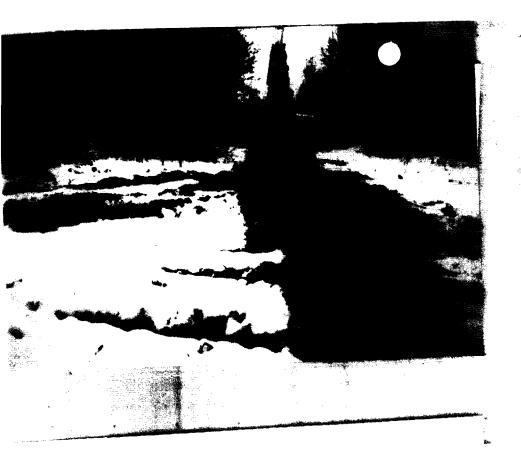
Photo #: 23 Roll: 1 Date: 11-21-96 Time: 0840

Facing south. Excavating approximately 2 feet of PCB-Description:

containing soils along the PGCS extraction trench

alignment.

The excavation activities, conducted in accordance with the November 14, 1996, plan, proceeded with a single pass of a back-hoe. The excavation extended to approximately two (2) feet below ground surface. The length of the excavation was approximately 100 feet, extending from the sample location ACS-PGCS-10 to the edge of the wetlands to the south.

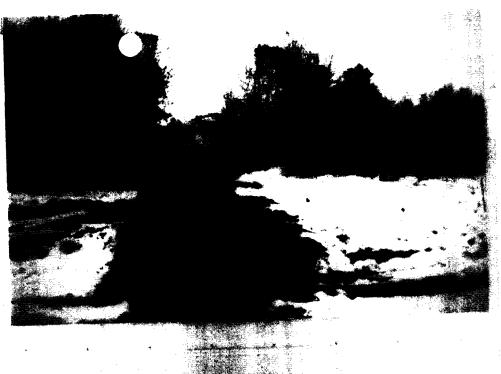
Photo #: 24 Roll: 1 Time: 0845 Date: 11-21-96

Facing south. PCB-containing soils along the PGCS Description:

extraction trench alignment were excavated and directly placed in the dozer bucket for transport to the stockpile

area.

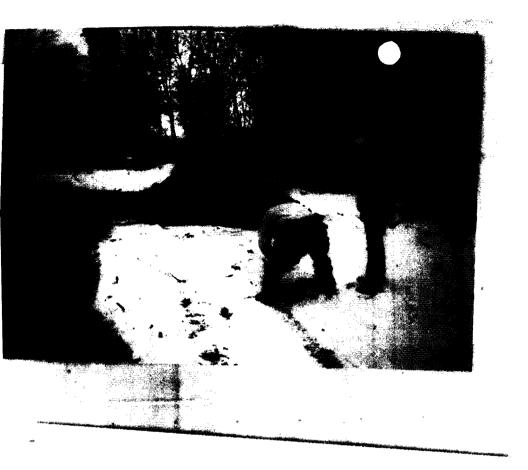
Photo #: 25 Time: ()9()()

Facing south. Placing additional plastic to stockpile PCBcontaining soils.

The excavated soils were stockpiled in the cleared area just west of the south end of the PGCS extraction trench. A plastic sheeting was placed underneath and on top of the stockpile. The stockpiled area was secured with a caution tape. BVSPC was informed that approximately one to two feet of clean soil cover will be placed over the top sheeting at a later date, i.e., during the construction of PGCS extraction trench.

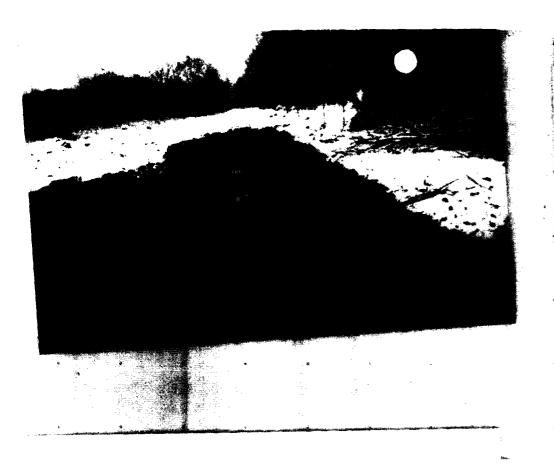
Roll: 1 Photo #: 27

Facing north. After completion, the PCB-containing soils exeavation along the PGCS extraction trench alignment

was temporarily secured with a caution tape.

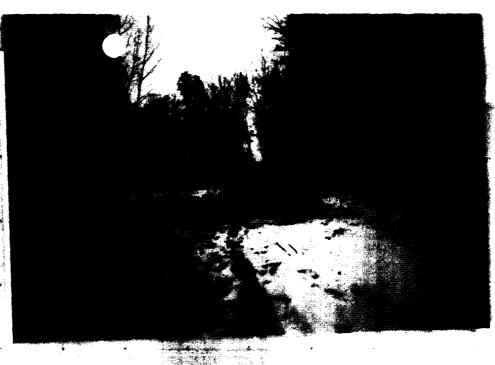
Photo #: 28 Time: 1115

Facing south. The PCB-containing soils were stockpiled in an area just west of the PGCS extraction trench location. The soils were covered with a plastic. The area

was temporarily secured with a caution tape.

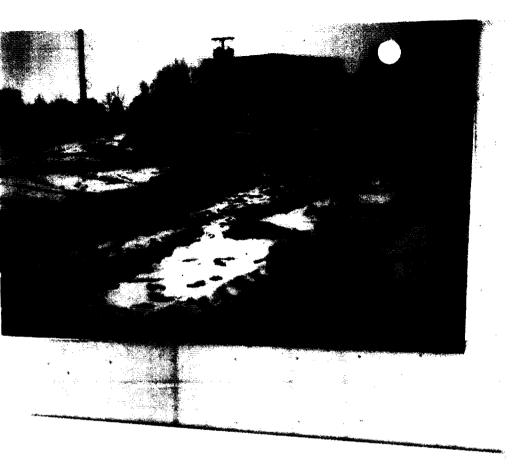
Roll: 1 Photo #: 29 Date: 11-21-96 Time: 1115

Description: Facing south. Natural gas line to the treatment building

being installed by Young's Environmental.

From November 20, 1996, through November 21, 1996, Young's Environmental installed the natural gas line to the treatment building. The installation activities consisted in placing a 4-inch HDPE pipe in a shallow trench, approximately 2 to 2.5 feet deep. All of the excavated materials were used to backfill the trench.
